February 25, 2019

Water Resources Department

Re: Winchester Dam (W-1) – Inspection Summary

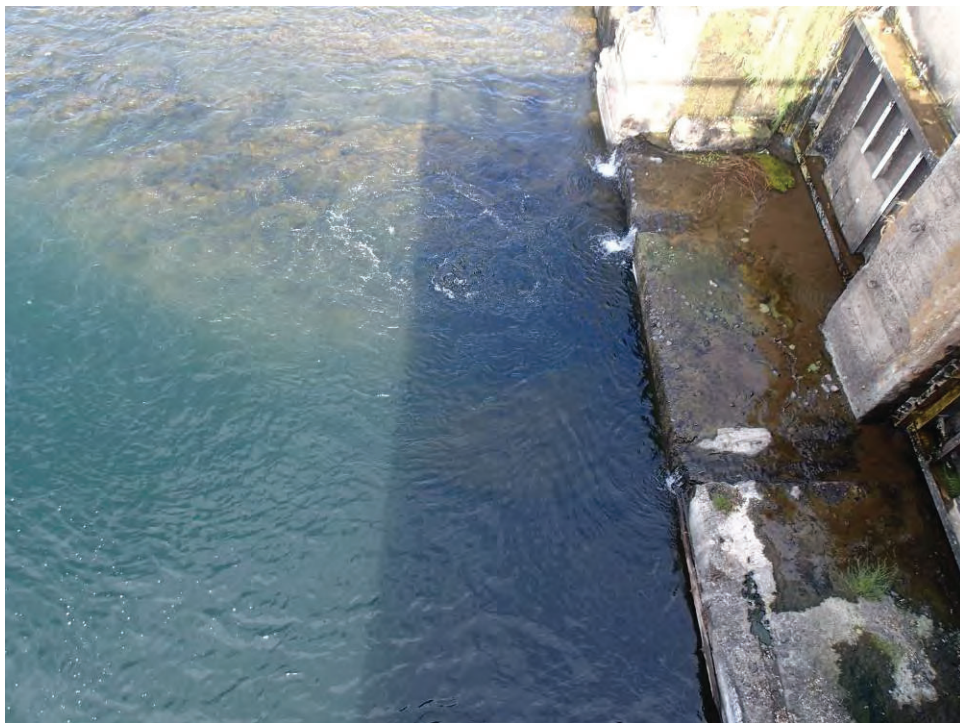
Reservoir: The main issue for this inspection was a significant increase in leakage under the dam, near the gates. During our inspections work to identify and reduce the leakage was underway. The work appears to have successfully identified the source area of leakage as a number of spots from the left abutment, above the powerhouse, and possibly extending to the area above the gates. **It is important to continue to monitor this dam for leakage.**

Leakage: This was the focus of our inspections. Prior to the start of the repairs on 10/23, water could be seen draining underneath the north corner of the old powerhouse foundation and surfacing from underneath the dam downstream of the gate structure. After the repairs were mostly complete on 10/25 no evidence of leakage was observed on either side of the dam. We also observed sheet piles that had been driven a long time ago, apparently in an attempt to control past leakage. Several of the sheet piles were very uneven and did not form a reasonable seal. Our observations indicate river gravels under the powerhouse, and definitely is the foundation for part of the powerhouse. These gravels appear to be open and subject to leakage

Upwelling from leakage below dam – October 3, 2018

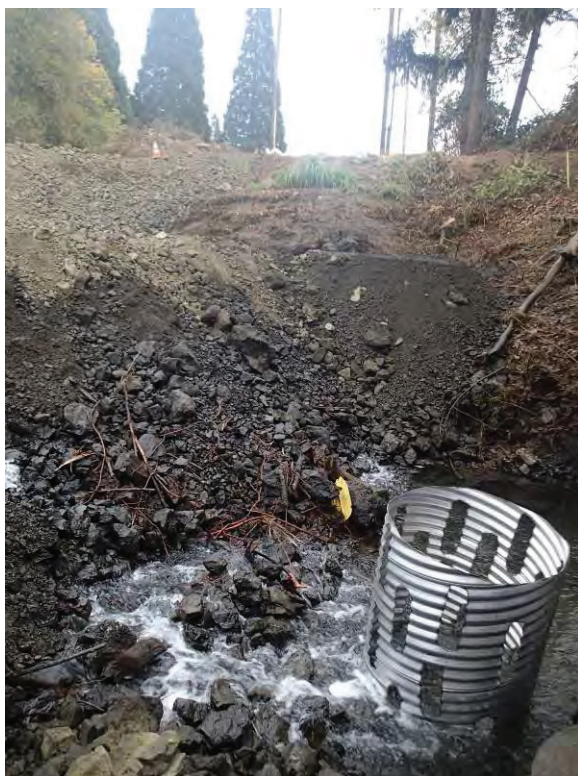
Excavation and flow control for repair – October 23, 2018

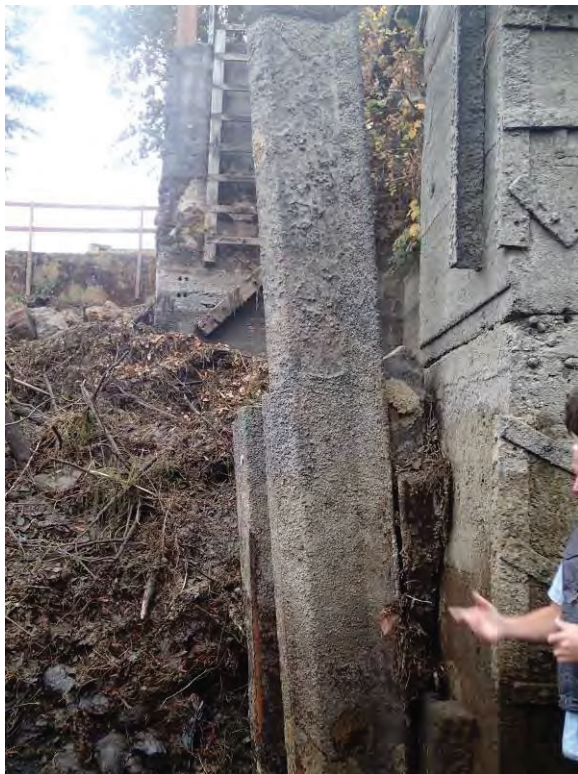
Exposed and ineffective old sheetpile – October 23

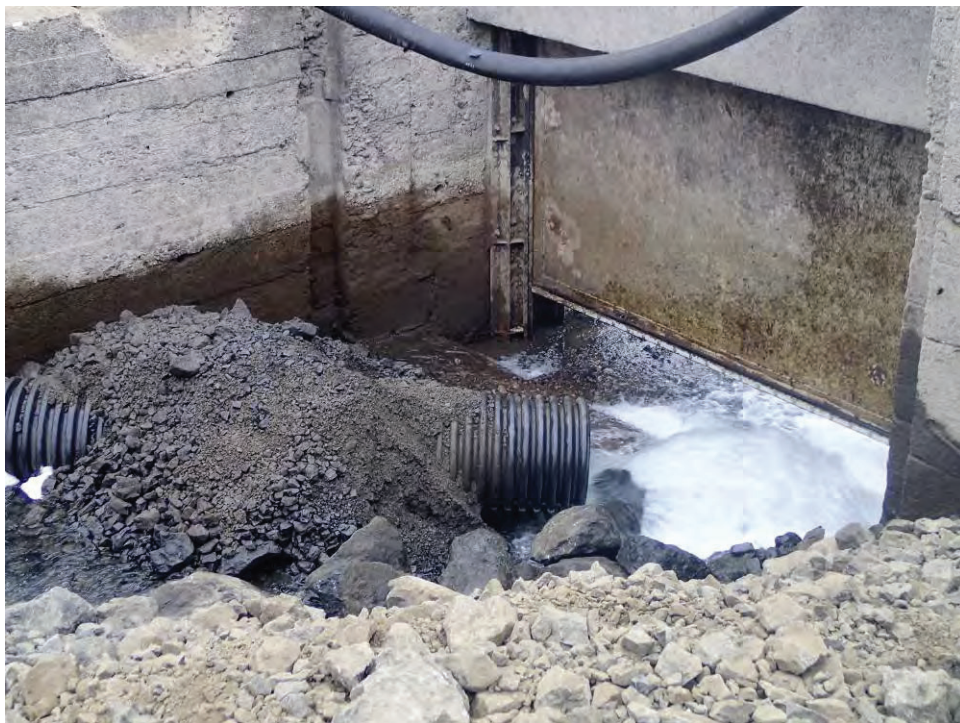
Gates: The inspection did not evaluate the gates in detail. One gate was opened and functioned to release water, mostly through a temporary culvert pipe laid from the leak area through the gate.

Flow through cofferdam directed under gate – October 23

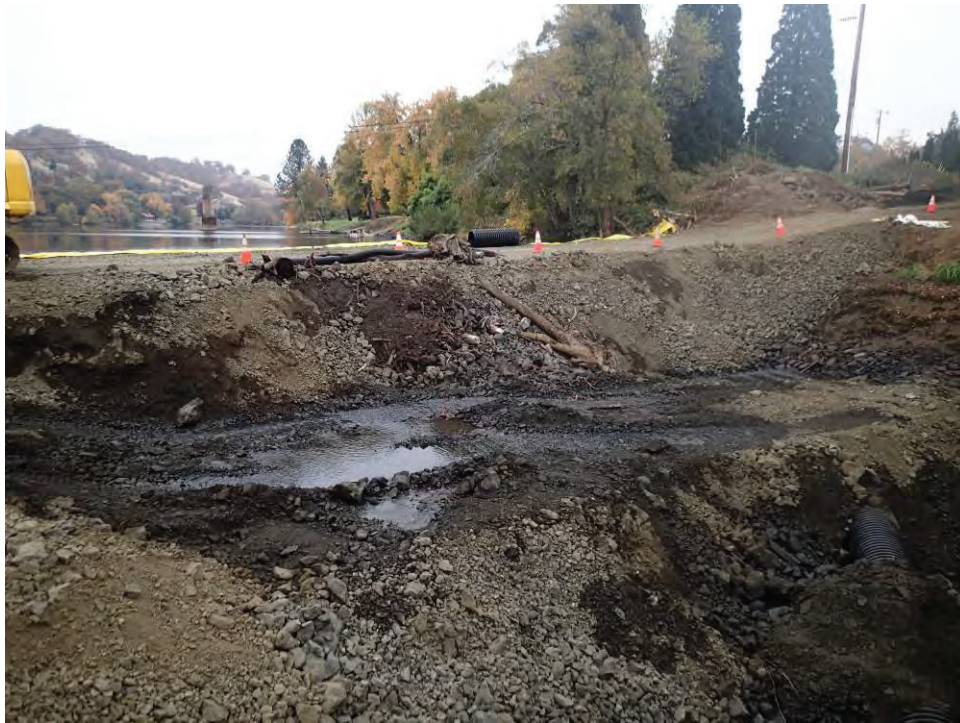
Access: Both sides of the dam are reasonably secure. Special and temporary access was developed with a gravel cofferdam around the area of leakage above the old powerhouse and gates.

Cofferdam – October 23, 2018

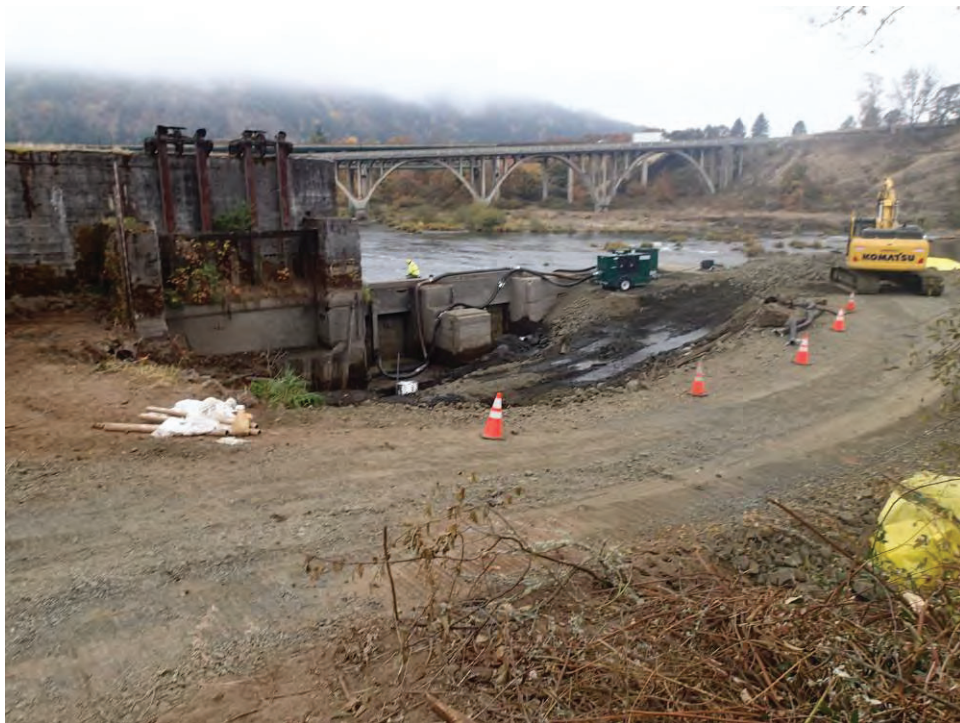
Site ready for concrete 10-23

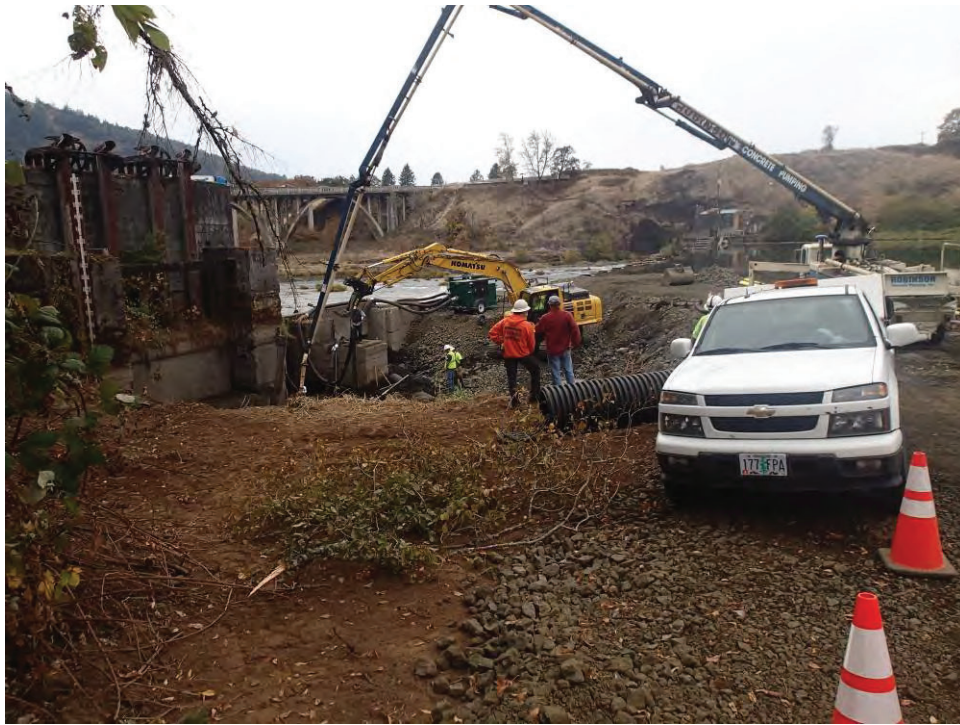
Pouring concrete - afternoon of 10-23

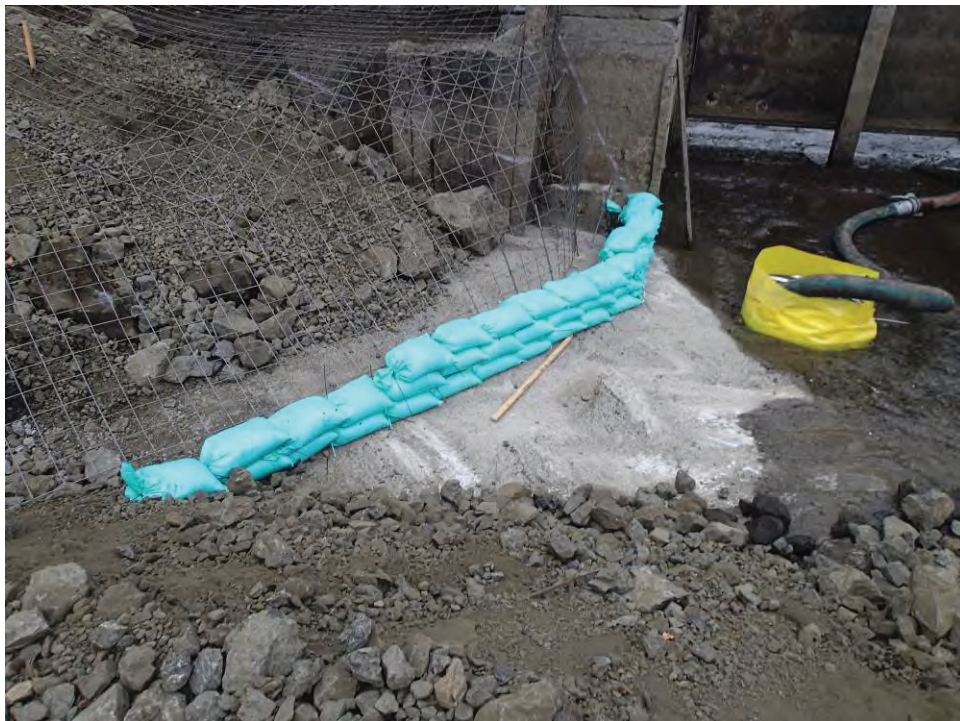
Summary: Due to other scheduled inspections during this time period we did not observe most of the construction activity. As of our final inspection, the repairs appear to have been effective in greatly reducing leakage and at least short term risk of failure by mechanism of undermining.

Concrete filling upstream leaks on October 25, 2018
